Seismic Evaluation – Phase 2: Report

Sonoma County – Chanate Hospital

ZFA Project: 14565

February 13, 2015

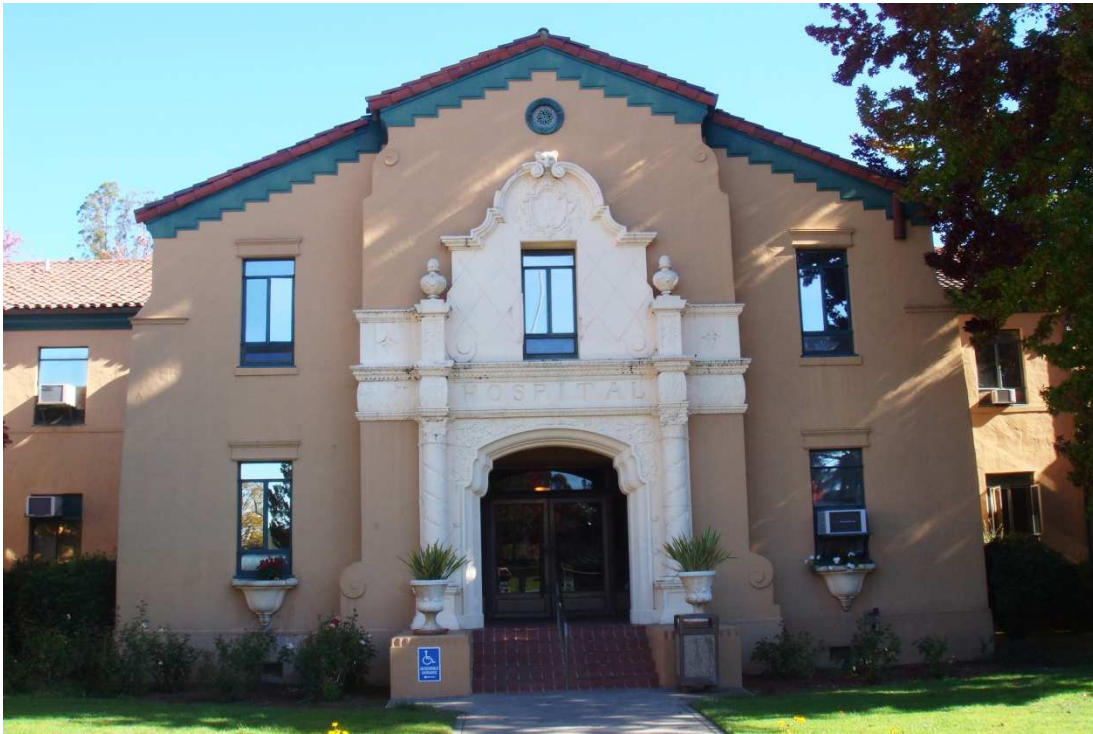
Photo 1: Building 7 – Main Entry at West Central Projection

Building 7 was designed in 1935 and constructed in 1936. Originally designed as an “I”-shaped building with smaller projections from the center, Building 7 was constructed without the northeast wing, southeast wing, and part of the east central projection, as shown in the original drawings. The building is adjacent to the 1956 additions to the north and the east (Buildings 3 and 8). The building is two stories with a full footprint basement and crawlspace, with a total interior floor area of 37,130 square feet. (See Appendix C – Photos 1 & 2, and Appendix B – Schematic Site Plan).

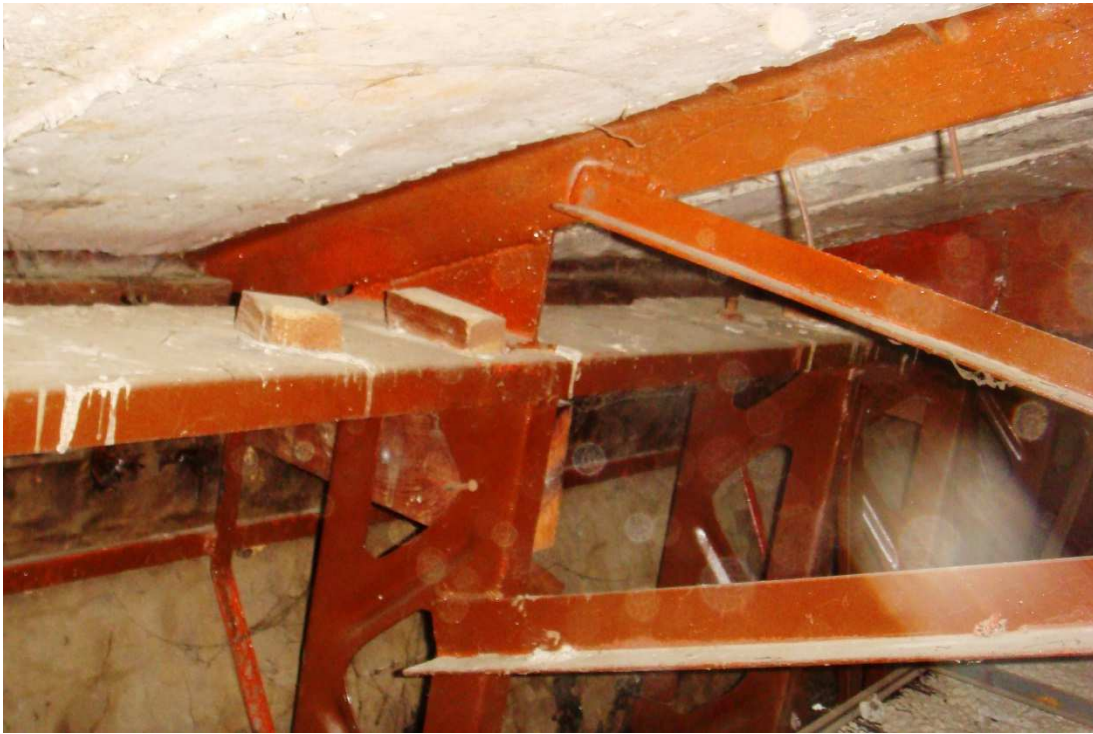
Photo 3: Roof Joist at Exterior Wall (note the lack of shear blocking and reliance on weak axis bending of thin gage truss heel; note minimal track splice at right)

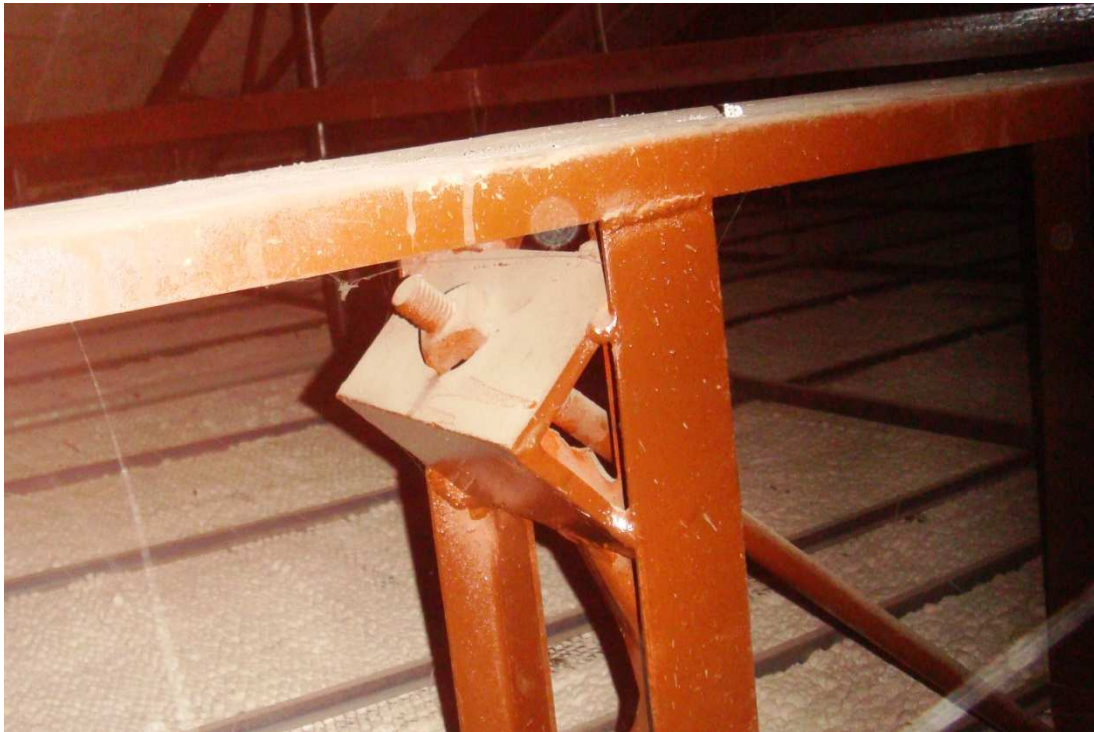
Photo 5: Interior Braced Wall Panel End Connection above Ceiling (note eccentricity and tack weld connections)

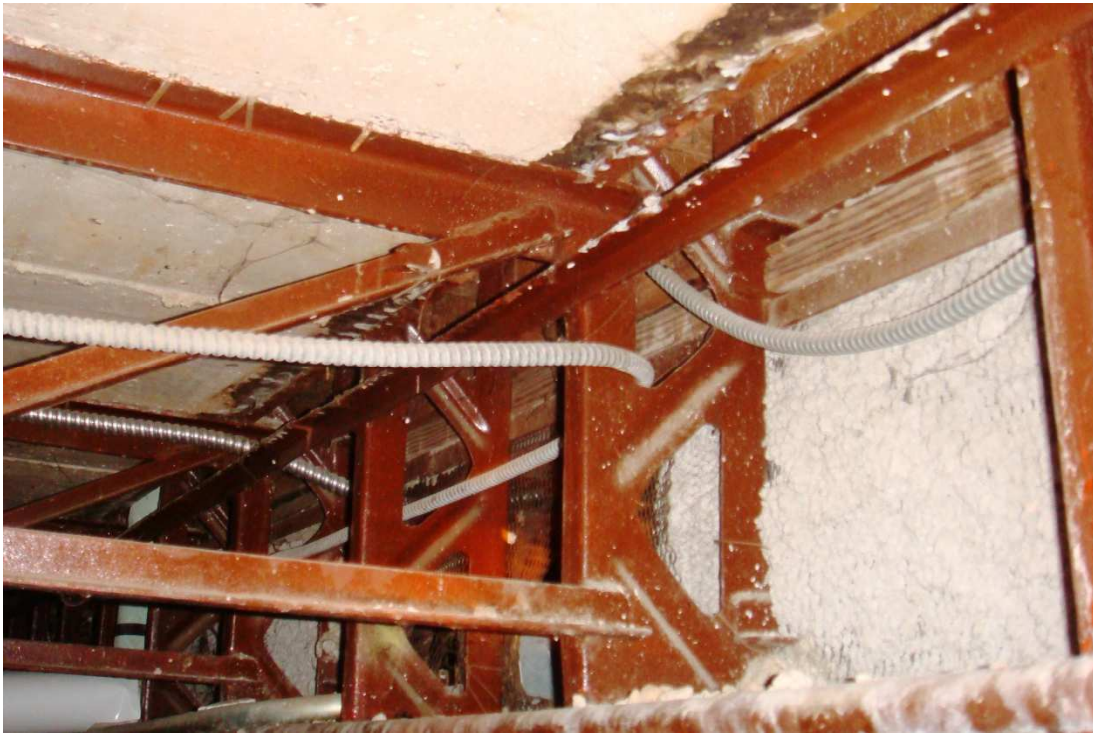
Typical exterior and interior bearing walls are light gage metal studs at 16" on center, with stucco or plaster over metal lath finish at the exterior or interior. Typical stud profile is 16gage thick by 6" deep, with 1" wide flanges (Appendix C – photo 9). The stud webs have large 3" maximum width triangular punch-outs and deformation of the remaining material, forming a truss-type configuration. Light "I"-columns occur at approximately 12' on center along the corridor stud walls, with a typical profile of 10gage thick by 6" deep, with 2" wide flanges and large triangular punch-outs. All metal stud walls run full height of the building, from 18 inches below the first floor to 18 inches above the second story ceiling. All full height stud walls disrupt the concrete diaphragms at the first and second floor levels. Partition stud walls not functioning as bearing walls do not run full height or interrupt the diaphragms.

Photo 9: Floor Joist at Corridor Wall (note lack of shear blocking at cripple studs and discontinuous diaphragm at full height wall studs; note minimal angle ledger with minimal splice at the left)

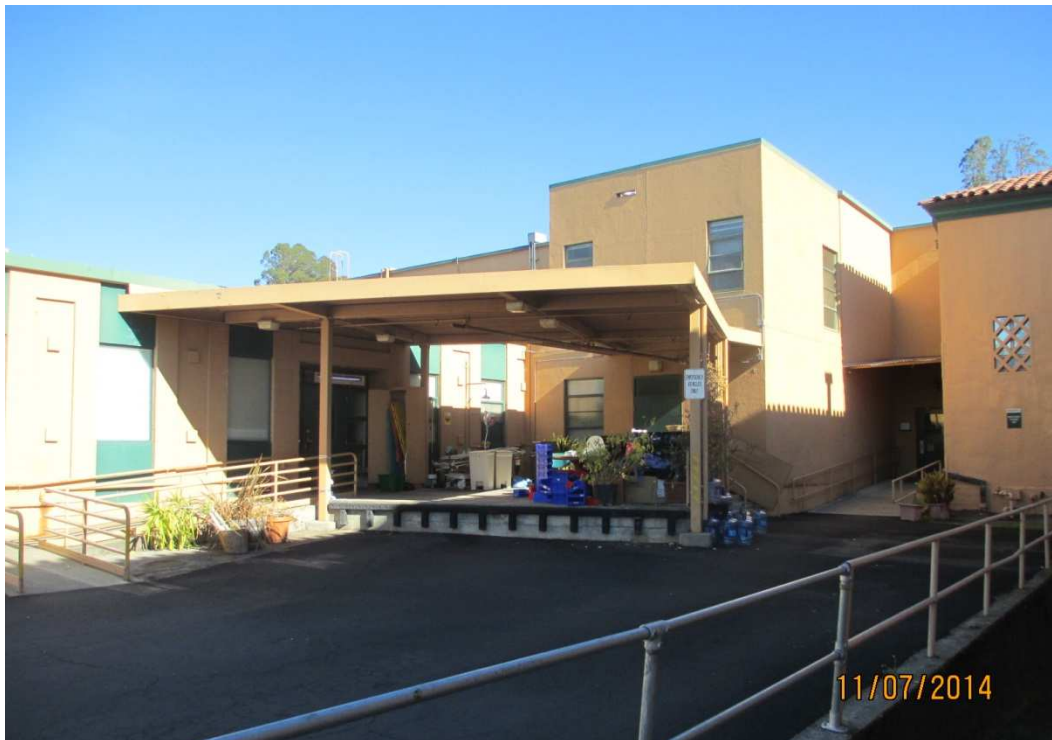
Photo 1: Building 9 – Southwest Elevation

The Ambulance Canopy/Dock (Building 9) was designed in 1987. The canopy is a one story steel structure with an elevated concrete loading dock previously used for ambulance offload to the 1956 Emergency Room and 1987 Observation Room/Restroom additions (see Photos 1 & 2 – Appendix C). The canopy is irregularly shaped and approximately 625 square feet.

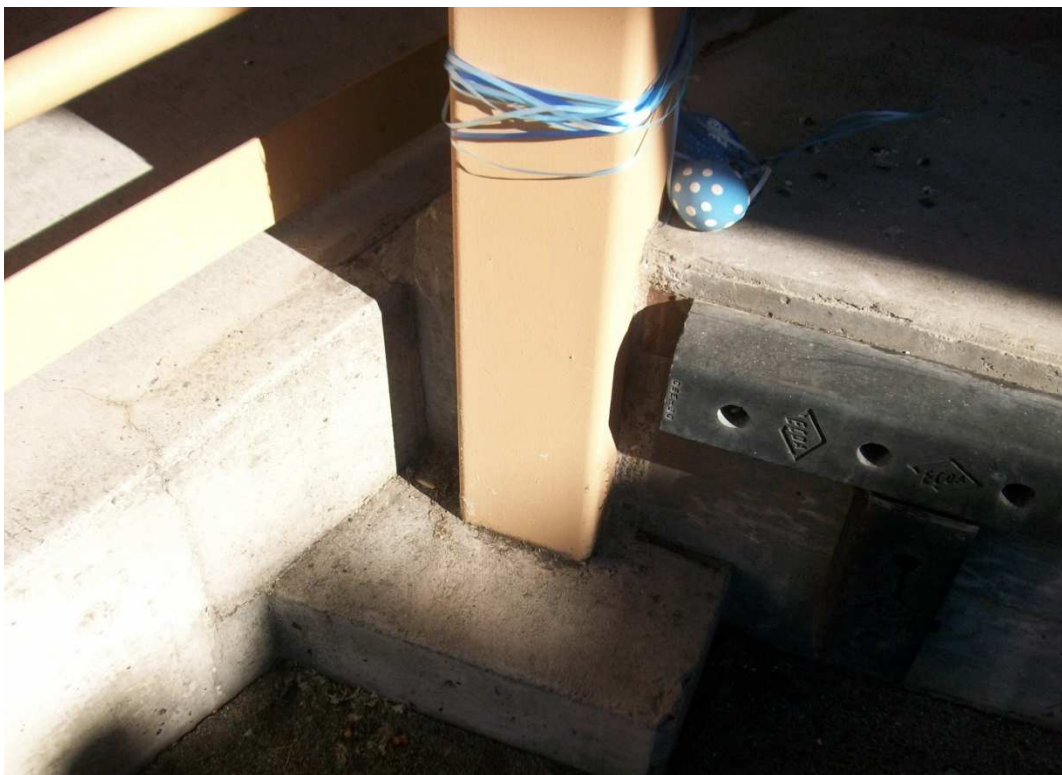
Photo 4: Building 9 – Cantilevered Column Fixed (Embedded) Base Connection

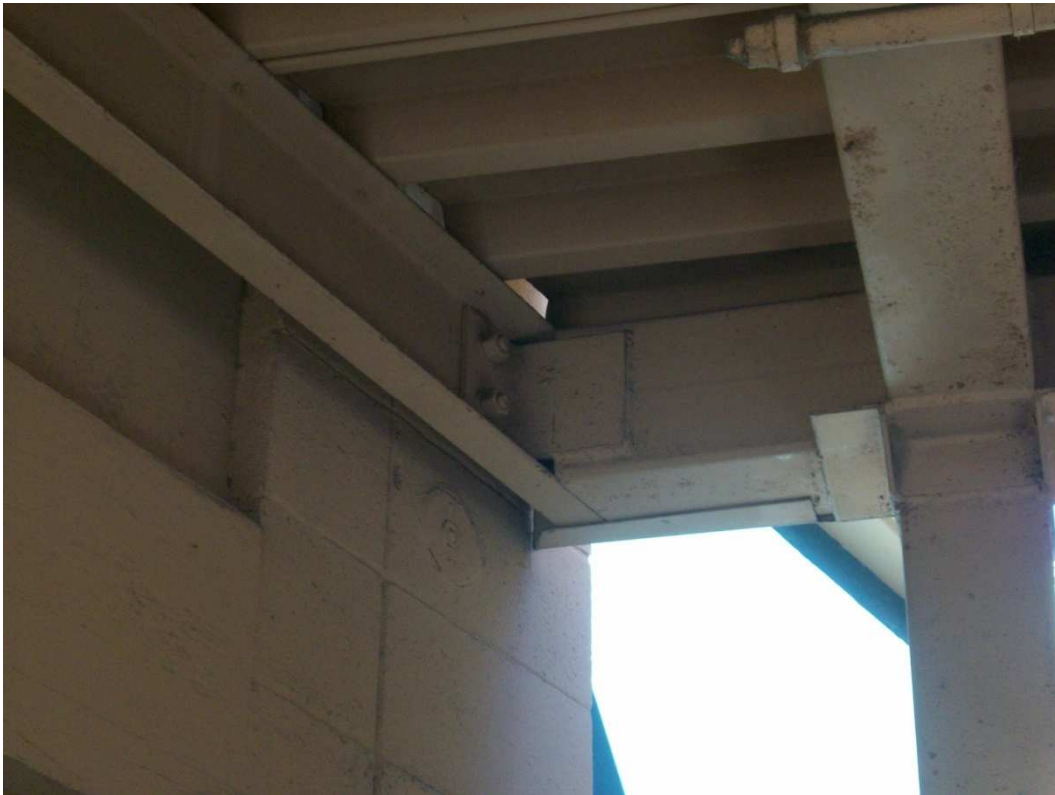
Photo 5: Building 9 – Northwest Seismic Gap

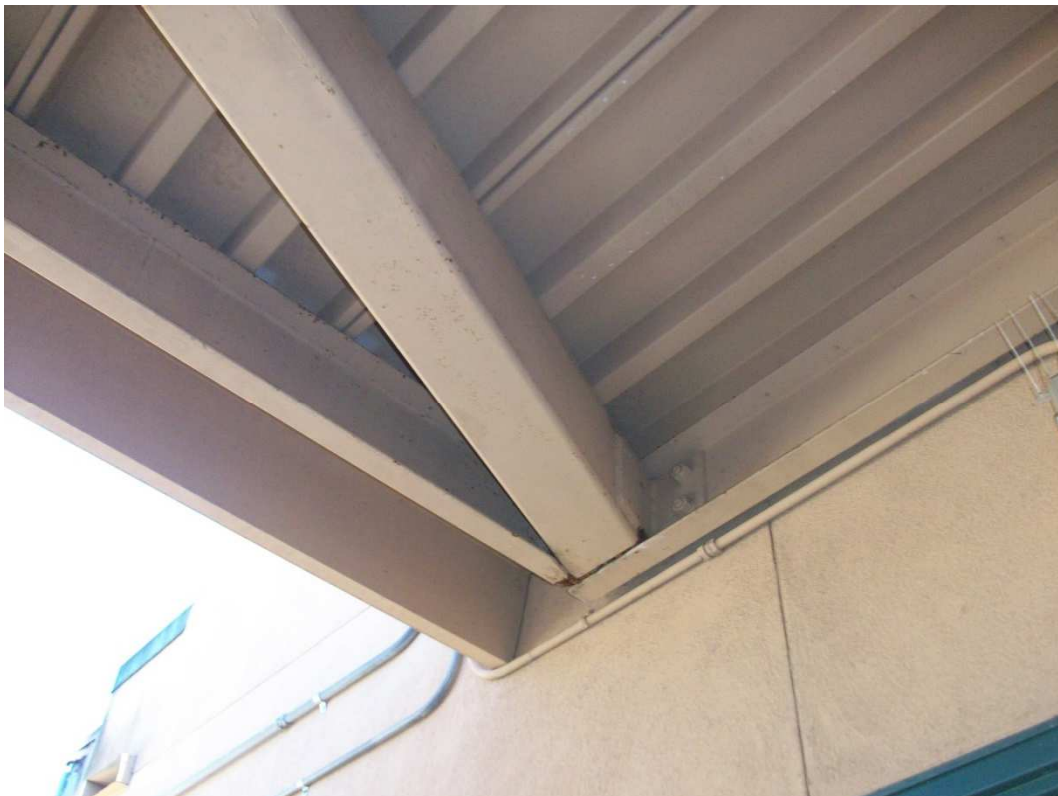
- a. ADJACENT BUILDINGS (ASCE Section 4.3.1.2) – *"The clear distance between the building being evaluated and any adjacent building shall be greater than 4 percent of the height of the shorter building for Life Safety and Immediate Occupancy."* The canopy is constructed with approximately 2 inches clear distance from the canopy structural steel to adjacent 1956+ Emergency Room Addition and 1987 Observation/Restroom Addition structures. Canopy finishes such as flashing and gutters have only approximately ½ inch clear distance to adjacent structures (see Photos 5 & 6 – Appendix C). Proximity to adjacent structure is less than the required 5.28 inches (4 percent of 11 foot canopy height), and is non-compliant.

Photo 6: Building 9 – Northeast Seismic Gap

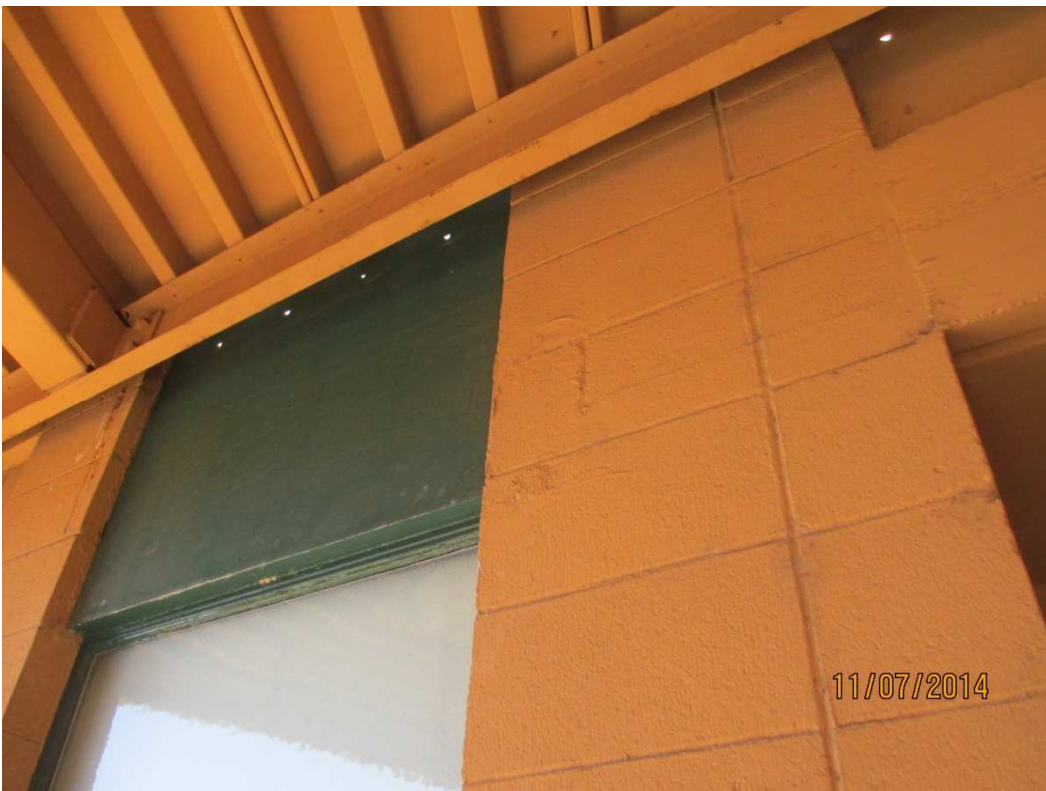
A larger ambulance canopy built in approximately the 1970's in the same location was reviewed in a 1978 H. J. Degenkolb & Associates, Engineers seismic hazard investigation report for the county and was deemed a probable collapse hazard in a seismic event due to direct connections to three seismically isolated structures. The direct connections would tear the canopy apart as the attached structures would move independently. This canopy was removed prior to the construction of the current canopy structure designed by MKM Structural Engineers. Removal of the condemned canopy was verified in field as the removed connections were still visible on the 1956 Emergency Room Addition concrete masonry unit wall (see Photos 7 & 8 – Appendix C).

Photo 8: Building 9 – 1973± Canopy Connection Removed
